RE: Site Inspection, Robert L. Clark, Clark #1 Mine, S/015/053, Emery County, Utah

Date of Inspection: June 7, 2002  
Time of Inspection: 10:00 a.m. to 12:45 p.m.  
Conditions: Clear, 80's  
Participants: Val Payne, Emery County Public Lands Council; Bret Miller; Dean Nyffeler and Tom Rasmussen, BLM; Paul Baker, DOGM

**ATTACHMENT**

**Robert Clark, Clark #1 Mine**

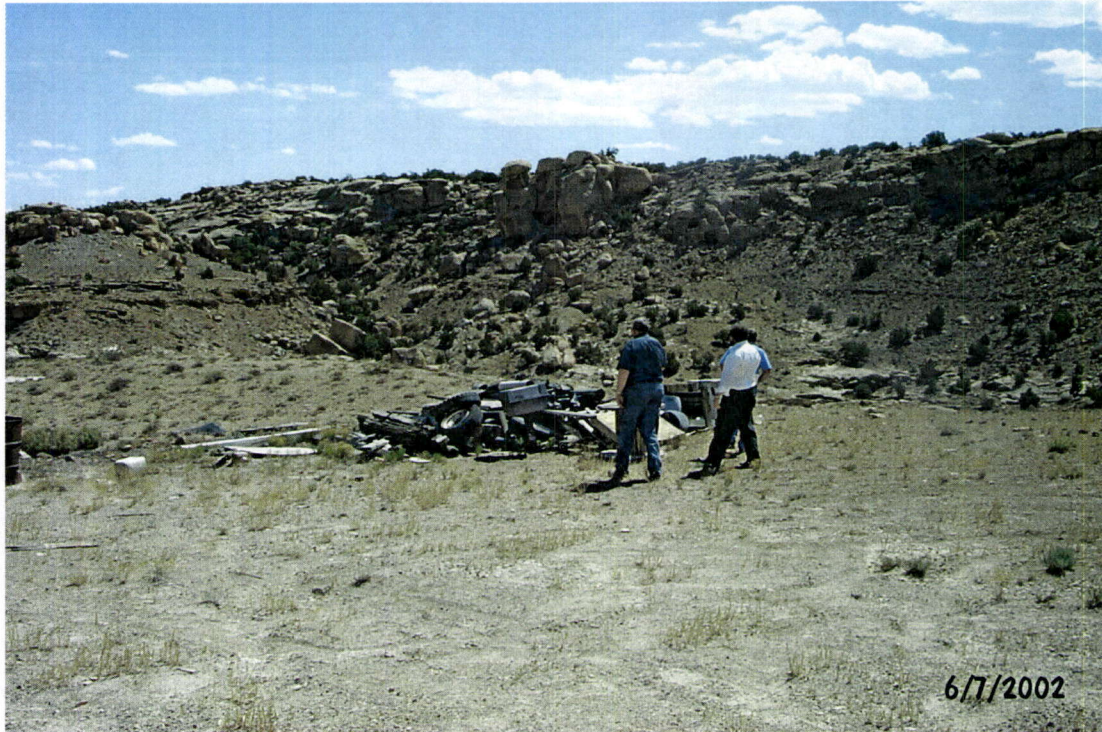
Photo 1 shows a pile of trash or scrap that needs to be cleaned up.

Photo 1. Trash or scrap that needs to be cleaned up.

Any trash or scrap needs to be disposed of or recycled, and equipment should be stored neatly in a consolidated manner.

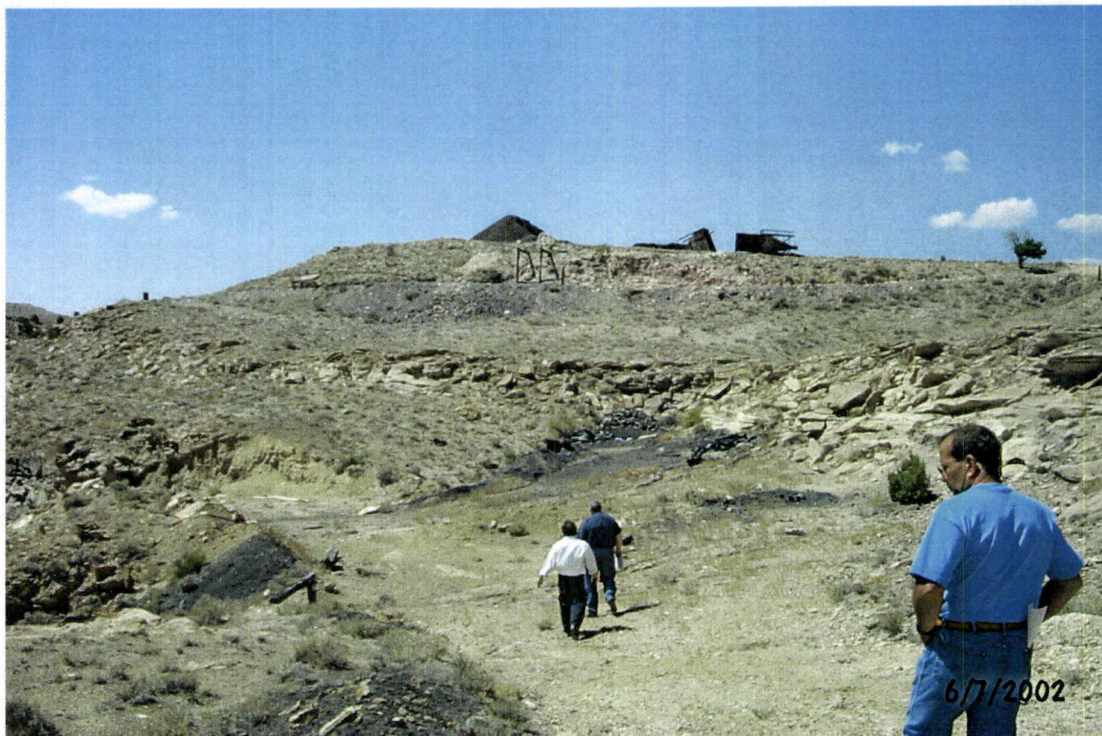
Photo 2. Road leading to the portals. The product stockpile associated with Bret Clark's mine is on top of the hill in the distance.

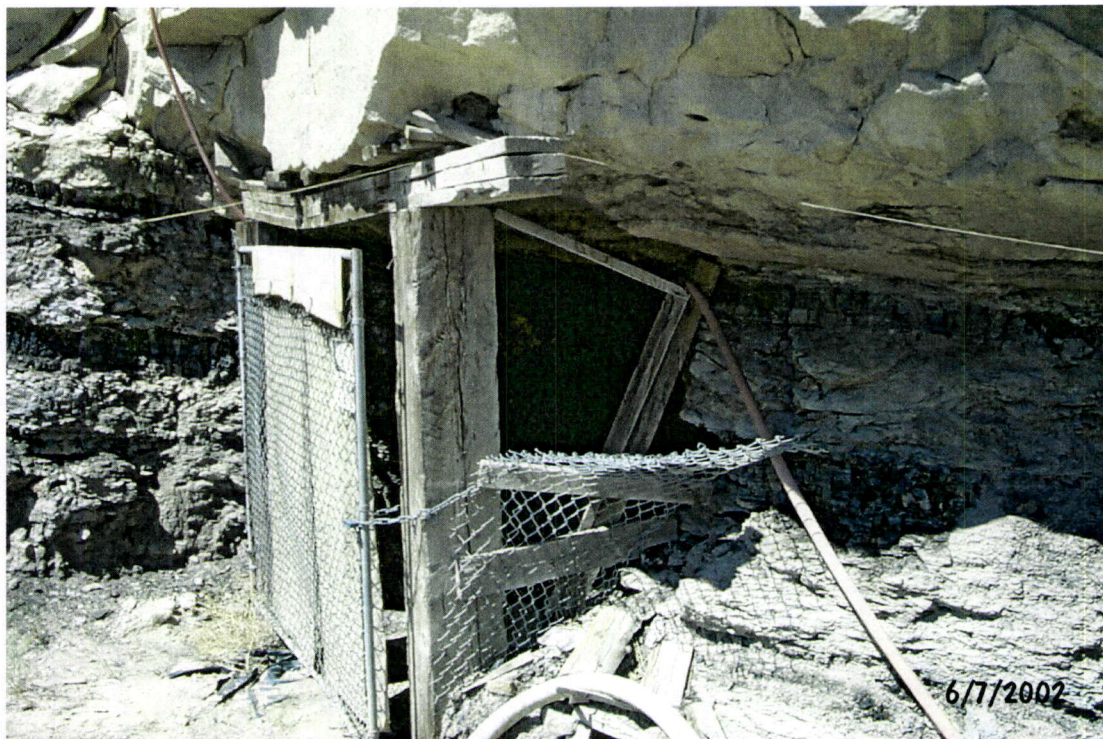
This mine has the smallest disturbance of the three brothers' mines in this area. There is a road going down to a pad where there are, as I recall, two portals, one of which is shown in Photo 3 on the attachment to this report. It appears it would be possible to gain entry to the mine through the fence across this portal. The portal needs to be secured.

Photo 3. Portal that needs to be secured.

The operator needs to secure the portal. This needs to be done as soon as possible. There should also be signs alerting the public to any hazards.

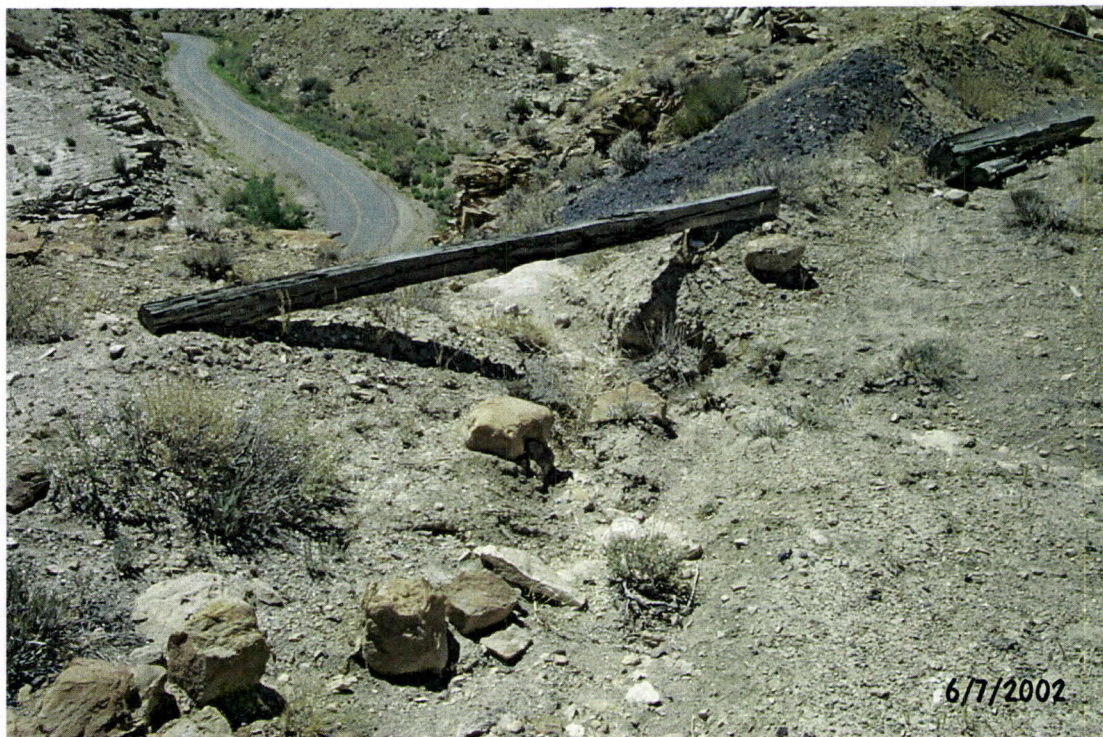
Photo 4 shows the outslope of the portal pad and a breach in the berm.

Photo 4. Breach in the berm on the pad outslope.

The operator needs to rebuild the berm both to control runoff and for safety. According to MSHA regulations, the berm should be at least as high as the axle of the largest equipment used at the site.
